Visual Survey of Potential Erosion Points on Royal Gorge Trails Bordering Serene Lakes

By George Lamson and Linda Cashion

7/19/13

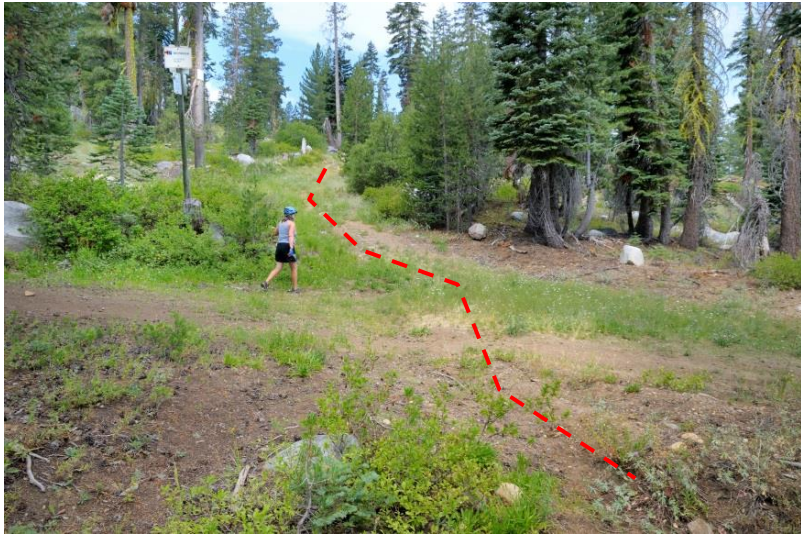
Erosion Point 1

View: Upslope Reindeer trail at this point is relatively flat with very little wear showing with some erosion occurring across the trail where the Kat's Walk connector crosses the trail. This could be easily armored to remediate any erosion. This is a heavily used trail by both hikers and bikers and wears very well. It is wide, has two well establish treads and has good straight sight lines.

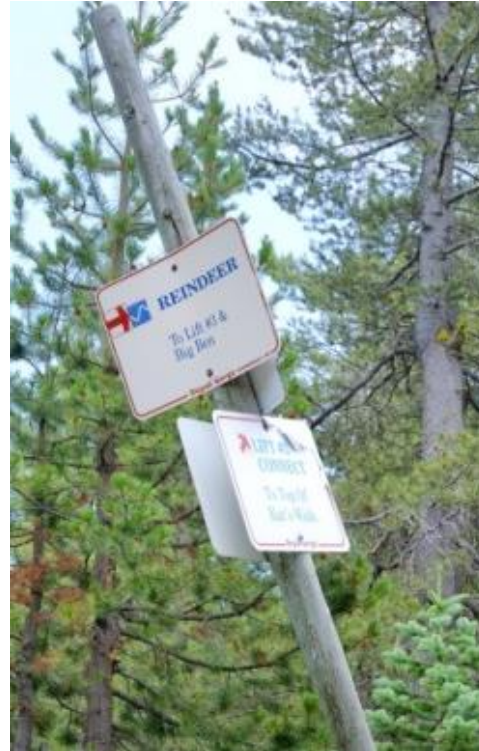
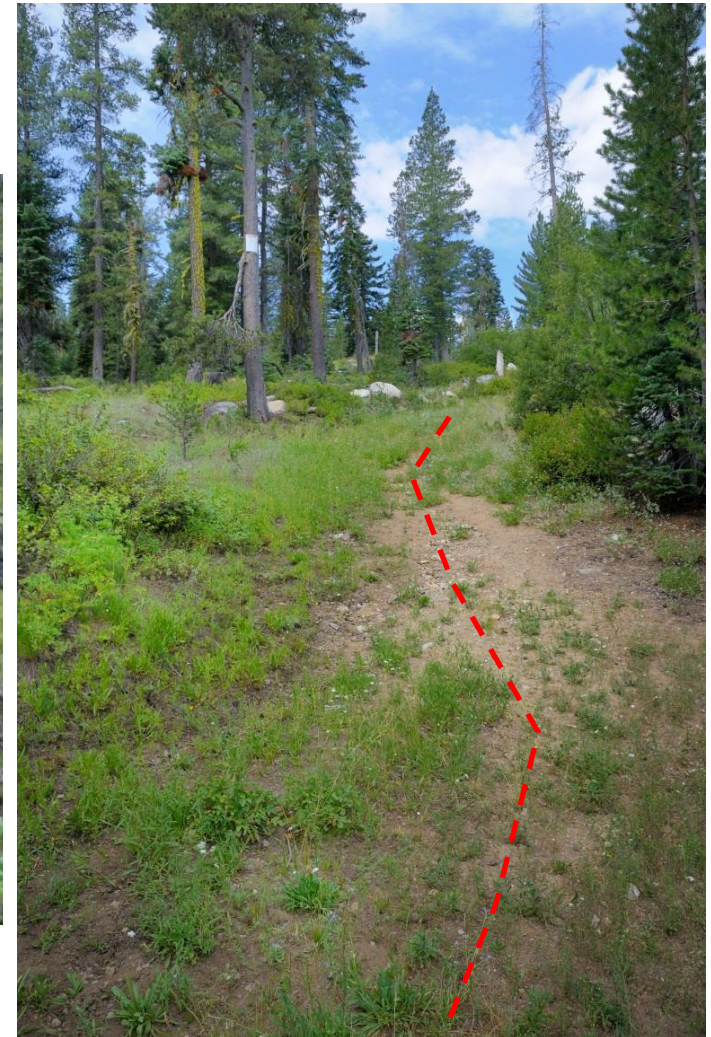
View: Upslope Kat's Walk connector trail drains straight down drainage line across Reindeer trail. Natural erosion does occur on the connector trail. Not really heavily used by mountain bikes or horses. Cross drainage would help.

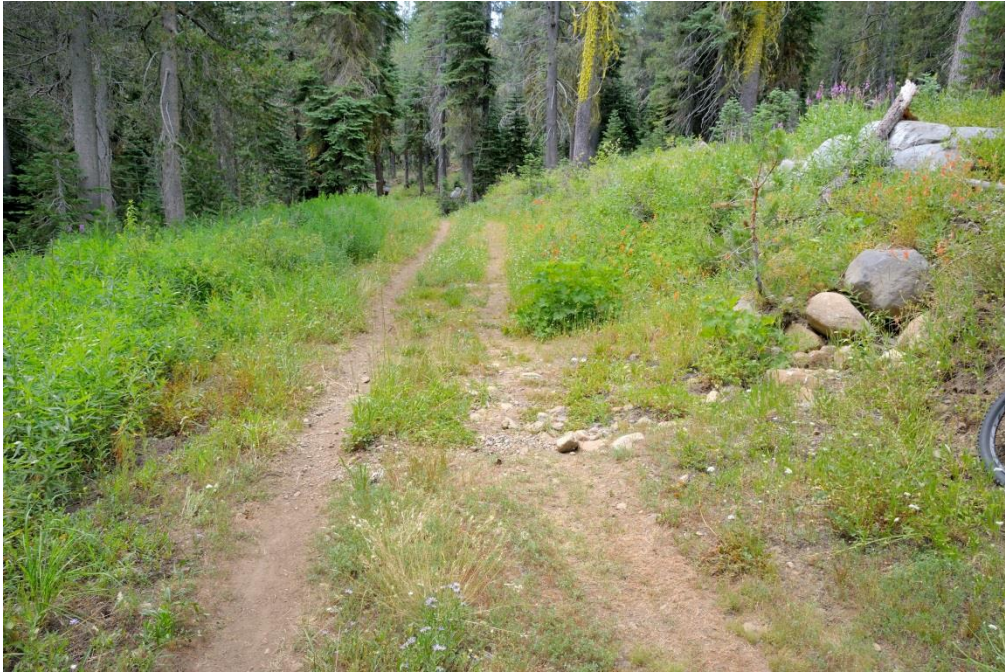
Erosion Point 2

View: South on trail Reindeer trail at this point is relatively flat with very little wear showing with some erosion occurring across the trail where a seasonal drainage creek runs (wet through June). This is a heavily used trail by both hikers and bikers and wears very well. It is wide, has two well establish treads and has good straight sight lines.

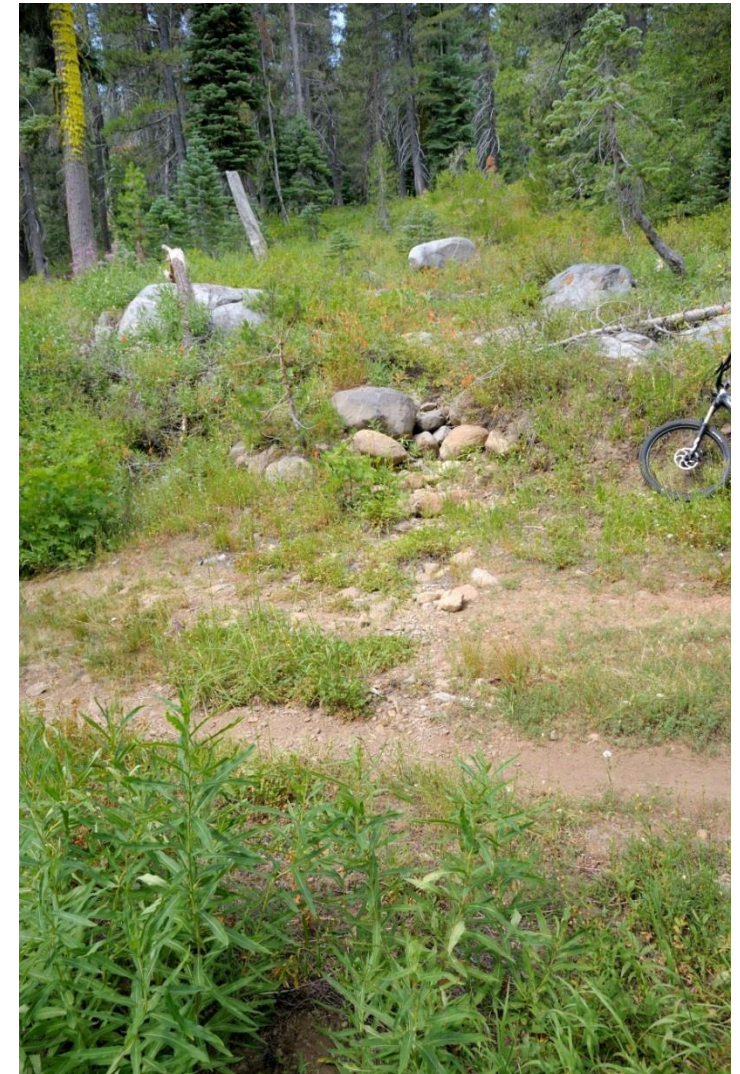
View: Upslope This seasonal drainage crosses Reindeer trail and does show some erosion. It is flat and hikers and mountain bikes have little impact. It could easily be armored with rock and gravel.

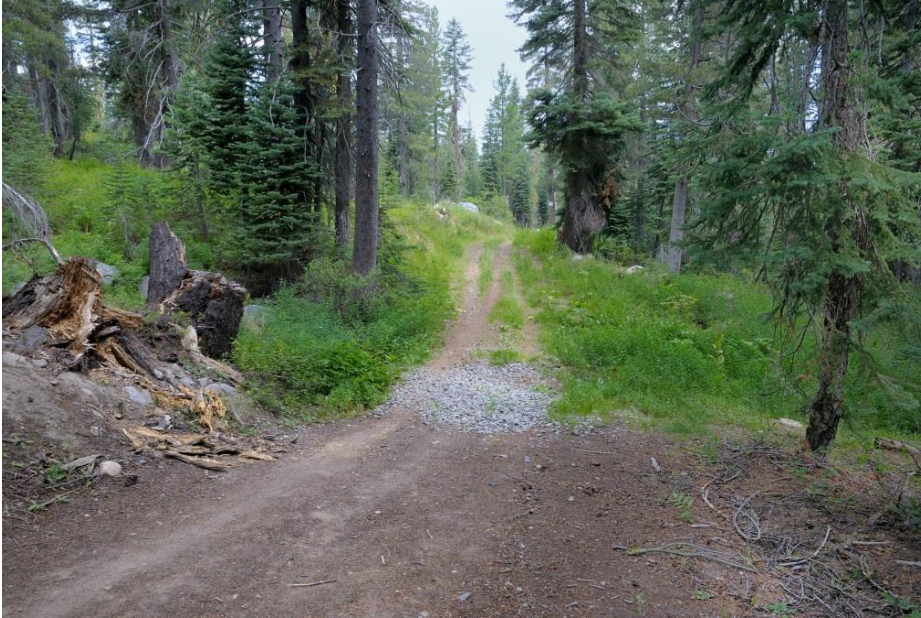
Erosion Point 3

View: North along trail Reindeer trail dips at this point and shows little wear. The slope of the dip is shallow and does not require braking for a mountain bike rider. The trail has been armored with large gravel which has proven effective in mitigating any erosion. This is a heavily used trail by both hikers and bikers and wears very well. It is wide, has two well establish treads and has good straight sight lines.

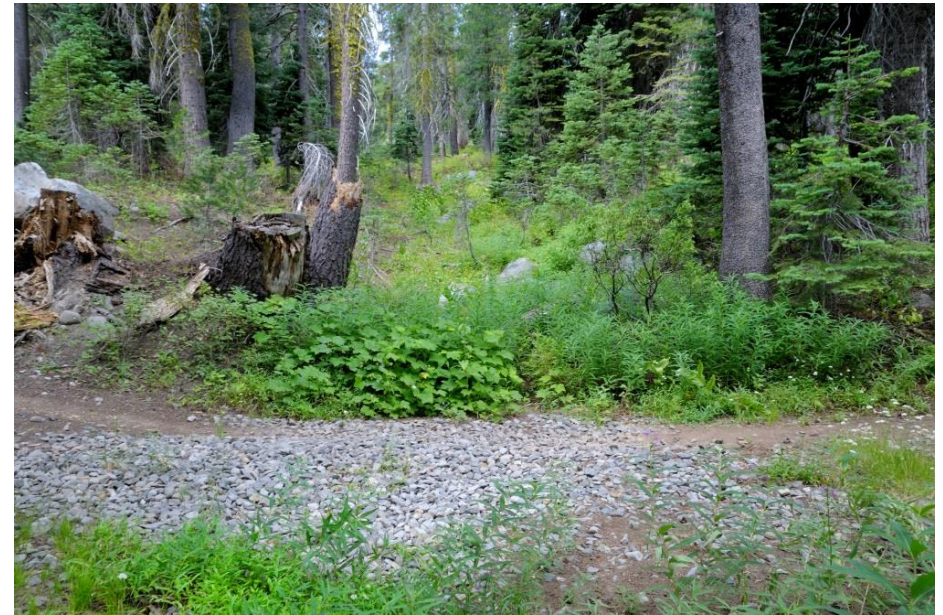
View: Upslope The drainage at this point is on a shallow slope that shows some natural erosion effects.

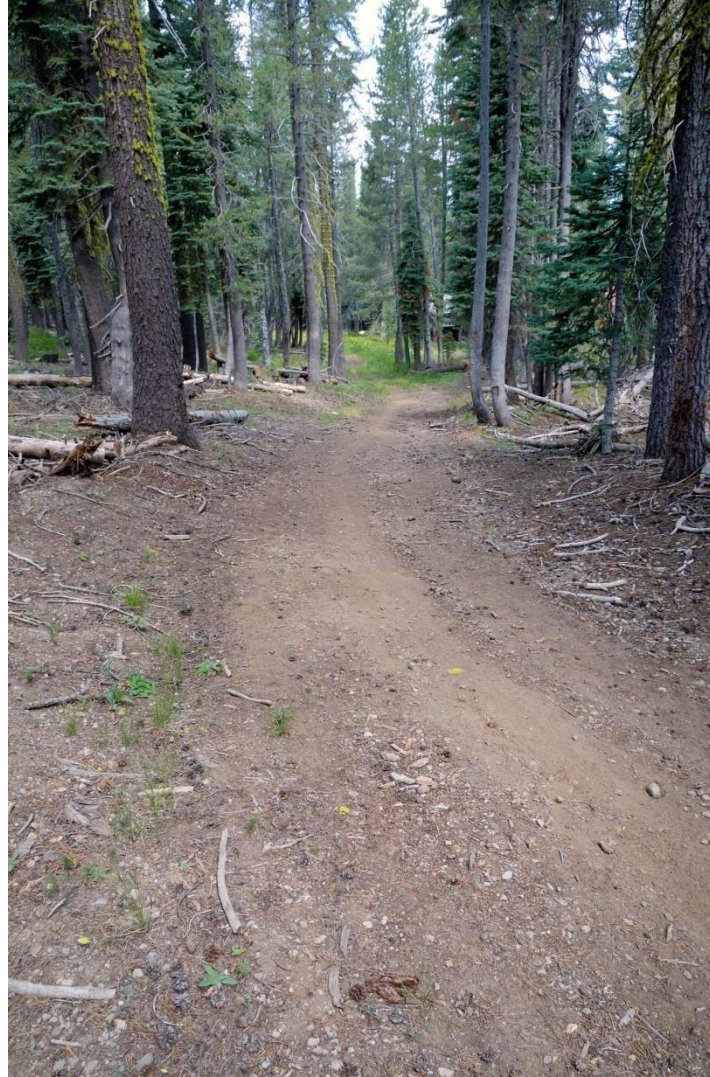
Erosion Point 9

View: North along trail Reindeer trail climbs significantly at this point. The soil on the trail is loose after it dries out in July and braking by mountain bikers going downhill is required which could enhance erosion. This section of trail will require remediation with cross drainage and grade modifications to minimize braking activity. This trail drains into the diversionary ditch behind Kidd Ct.

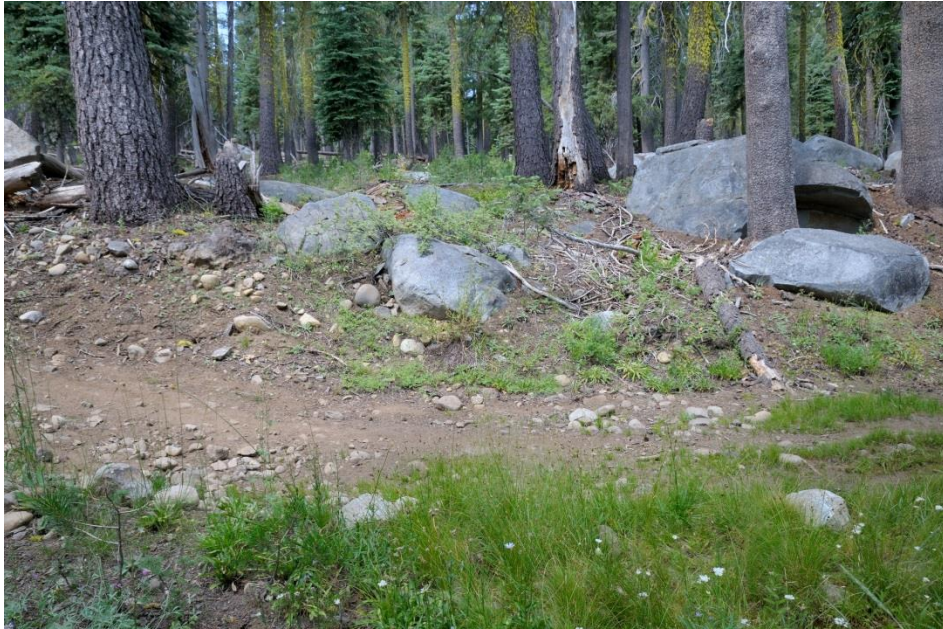
Erosion Point 11

View: Upslope This section of the Reindeer trail is flat but shows signs of significant drainage across it. The tread is somewhat deteriorated and will need compaction and drainage control remediation.

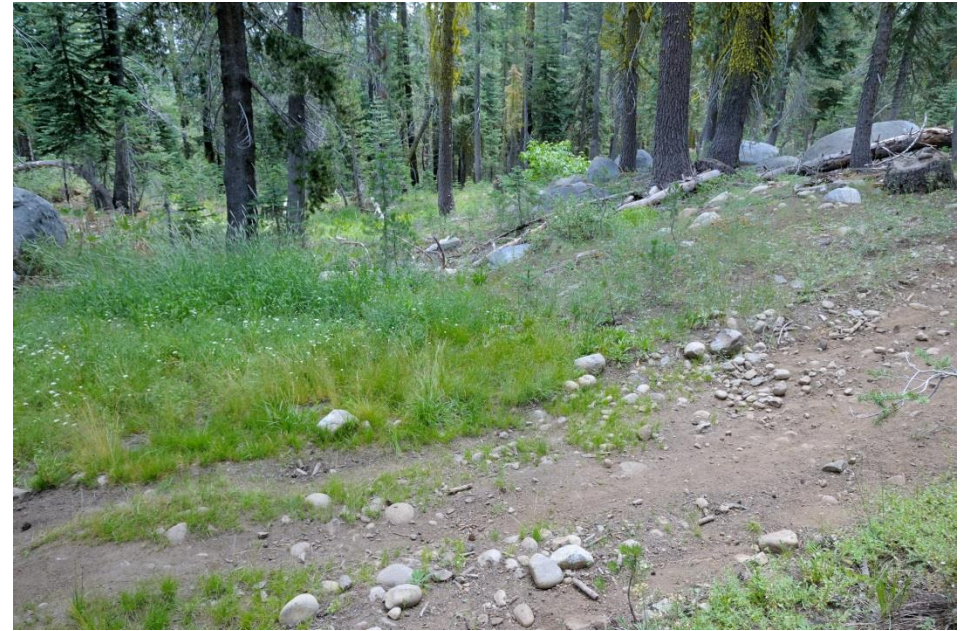
View: Downslope The drainage below the trail is relatively steep. The drainage runs into a diversionary ditch

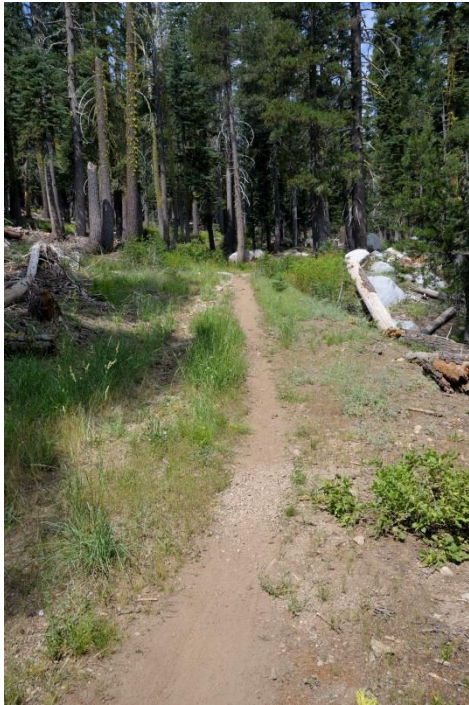
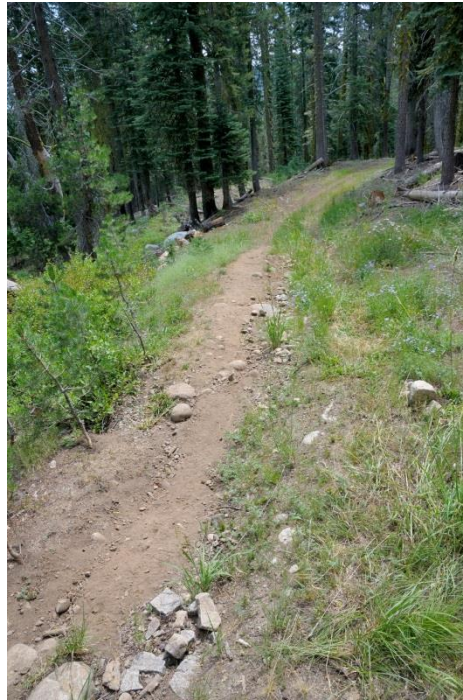
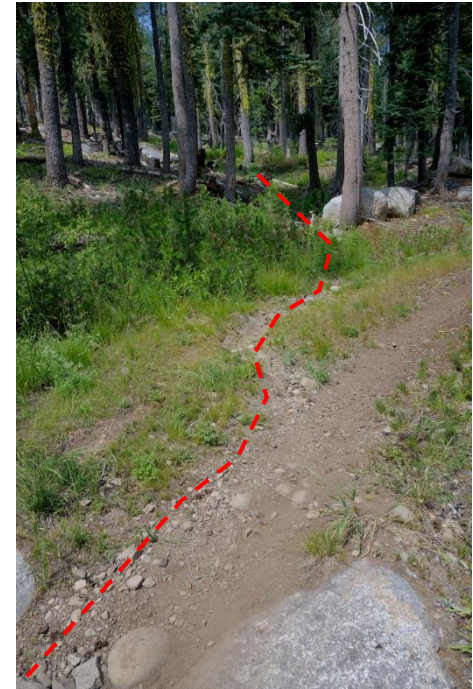
Erosion Point 12

Reindeer trail drops relatively steeply at this point. It would require strong braking by mountain bikes which could enhance erosion. There is only a single tread which is somewhat deteriorated. Drainage follows the trail for about 100 ft. This section of the trail would require drainage remediation and grade modifications to prevent severe braking.

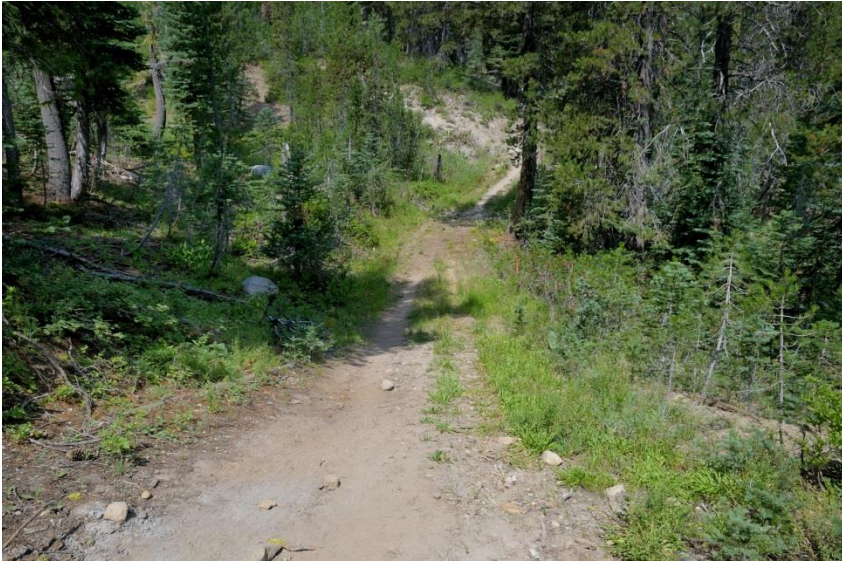
Erosion Point 13

View: North along trail. The point is a large dip in trail that is relatively steep on each side. It requires mountain bikes to brake in both directions which could enhance erosion. The trail will require drainage remediation and grade modification.

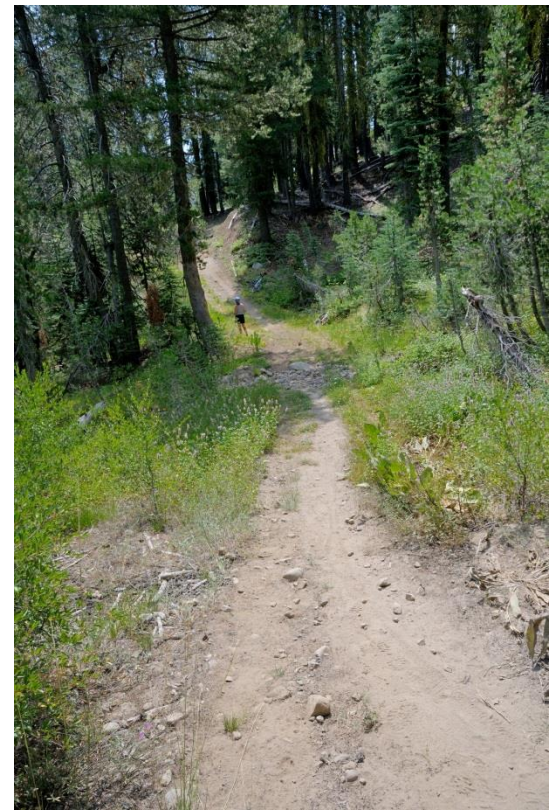
View: South along trail. Single track with some tread deterioration.

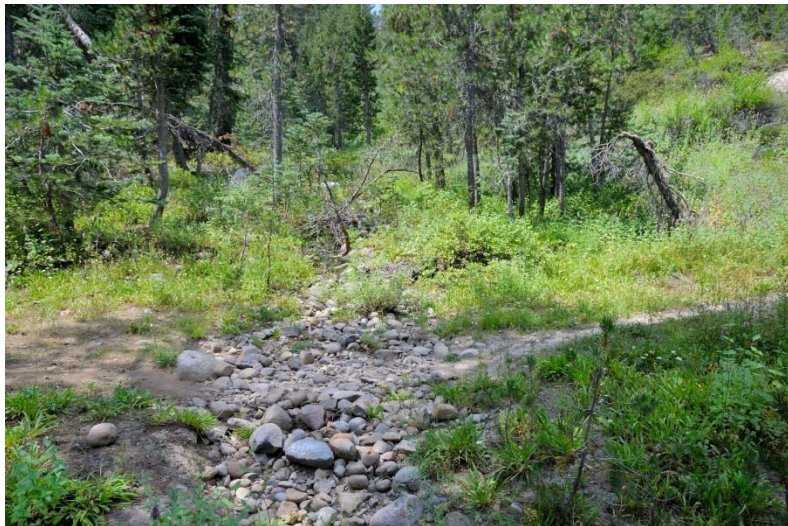
View: Upslope Trail shows significant wear from drainage

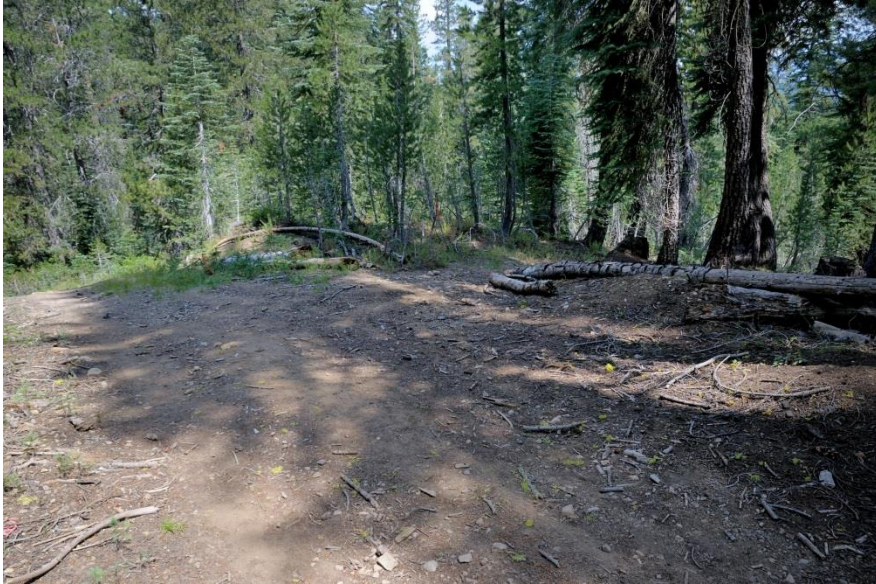
Erosion Point 14

View: North along trail. The trail rises here and the soil is loose when it dries out in July. It requires breaking by mountain bikes which could enhance erosion. It will require drainage remediation and grade modification.

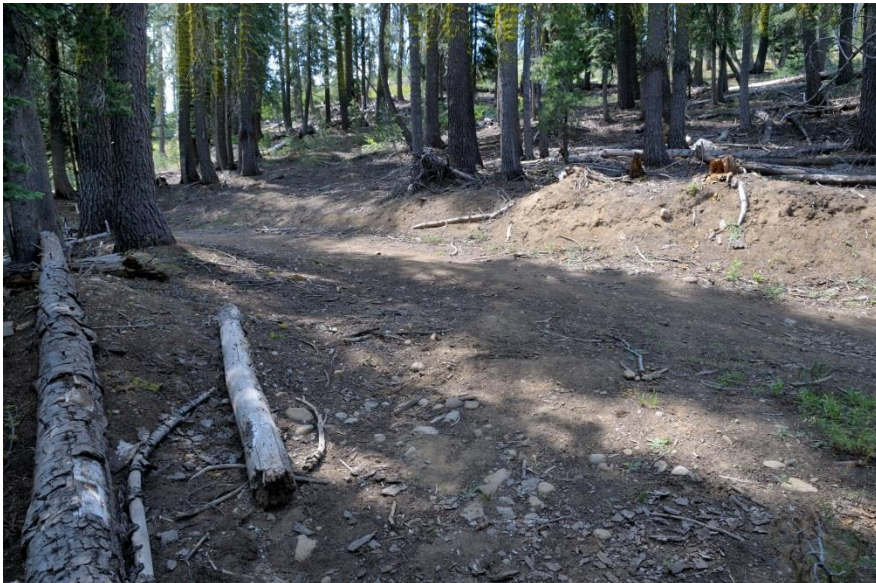
View: Upslope Soil in this area is loose when it is dry.

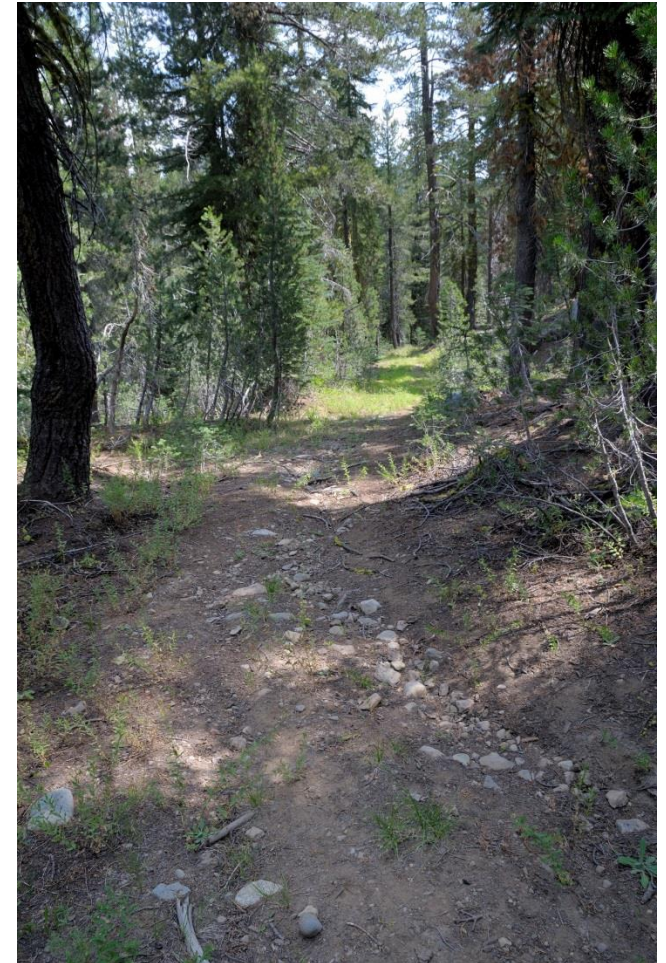
View: Downslope Drainage is steep and straight. Shows erosion wear. Will require drainage remediation.

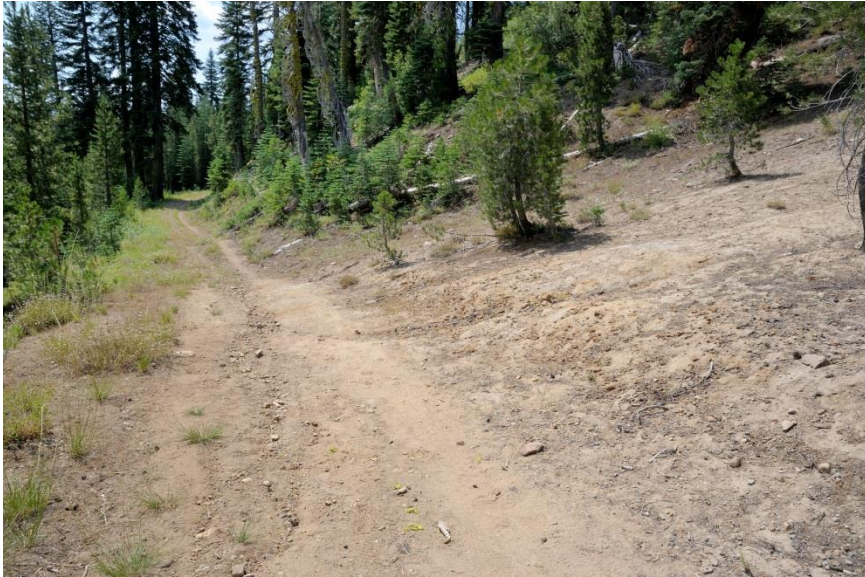
Erosion Point 15

View: South along trail. The trail at this point is a shallow slope that does not require mountain bikes to brake. The trail is in good shape but the upslope and downslope are naturally eroded.

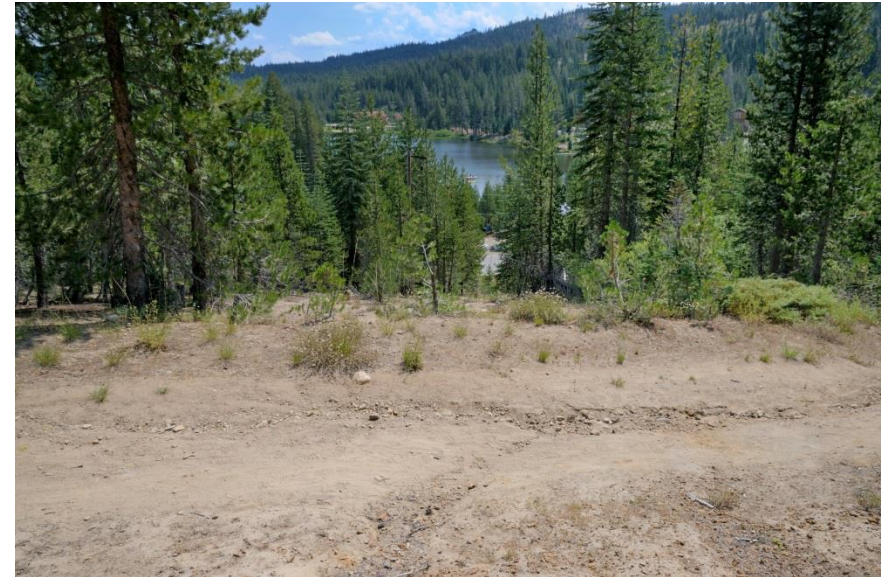
View: Downslope. This section of the trail is crossed by a wide area of natural slope erosion through a break in the forest on a steep grade.

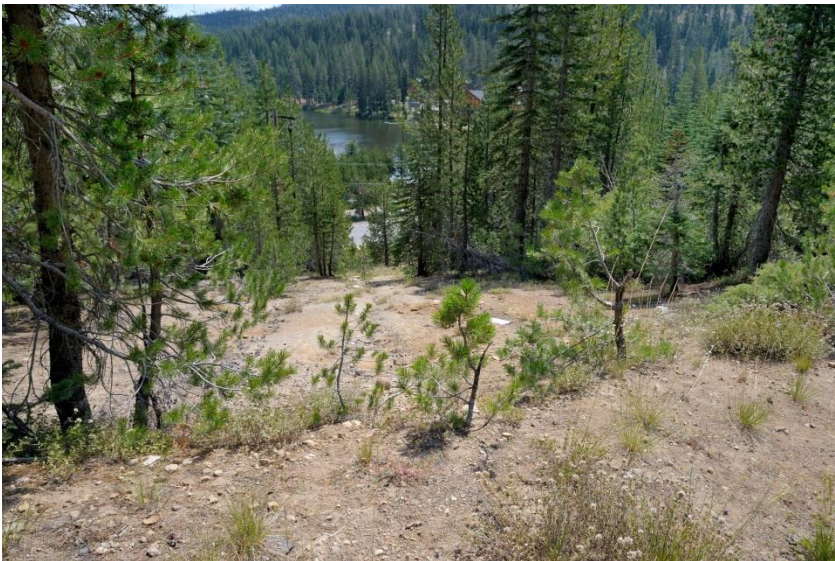
View: Downslope. Steep eroded slope beneath trail

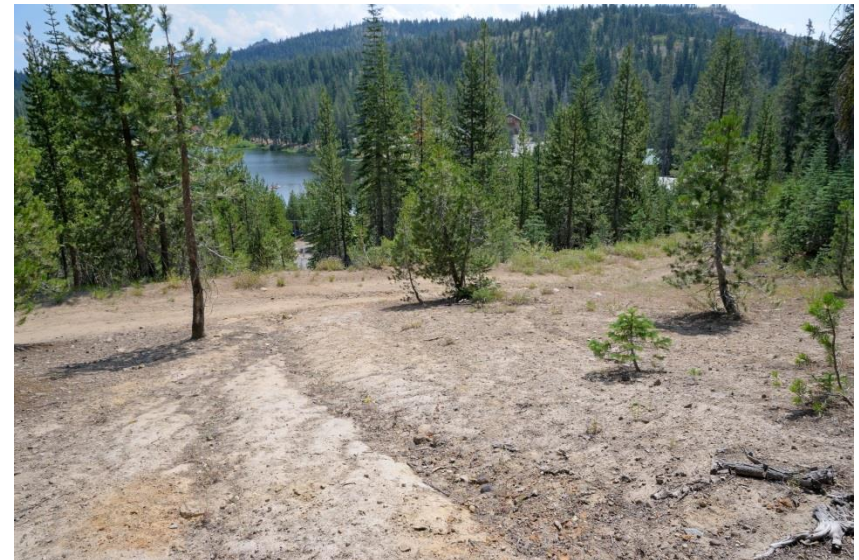
View: Downslope going down to the trail. Erosion on bare slope above trail is evident.

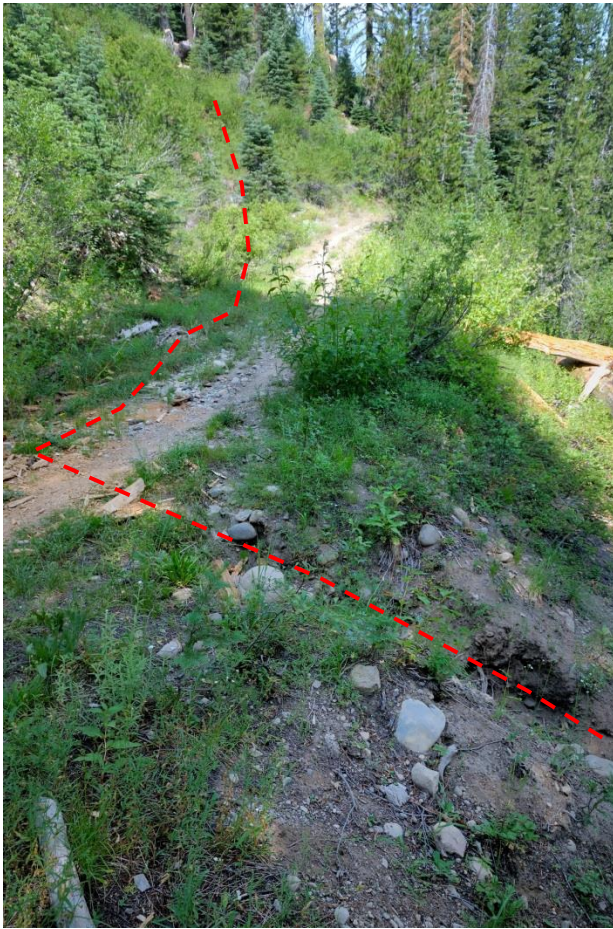
Erosion Point 16

View: North along trail. Trail at this point is relatively steep and requires a mountain bike to brake. The tread of the trail is single track and deteriorated.

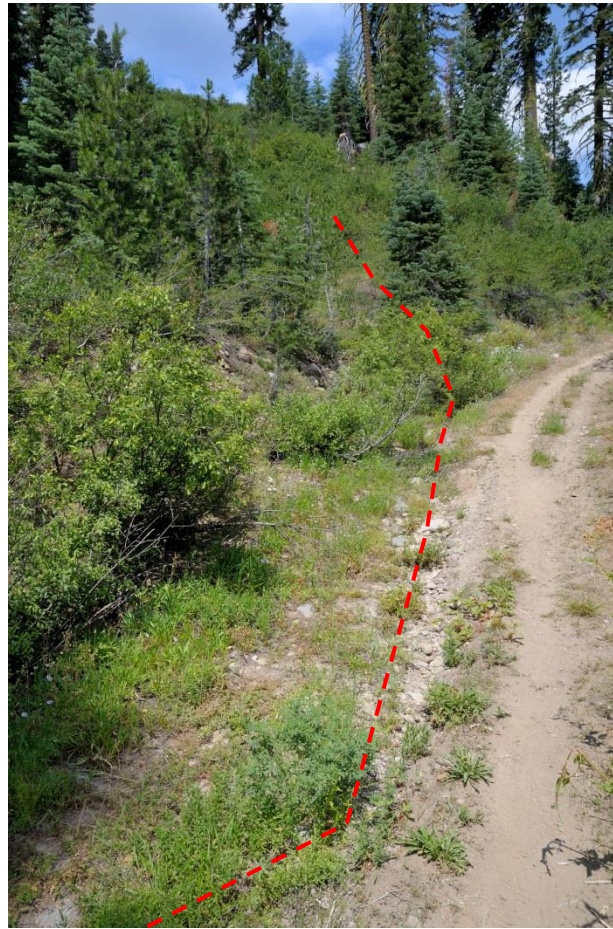
View: Upslope The natural drainage is steep on the upslope side and water drainage follows the trail for 50-60 ft. The trail will require drainage remediation and grade modifications to minimize erosion effects.

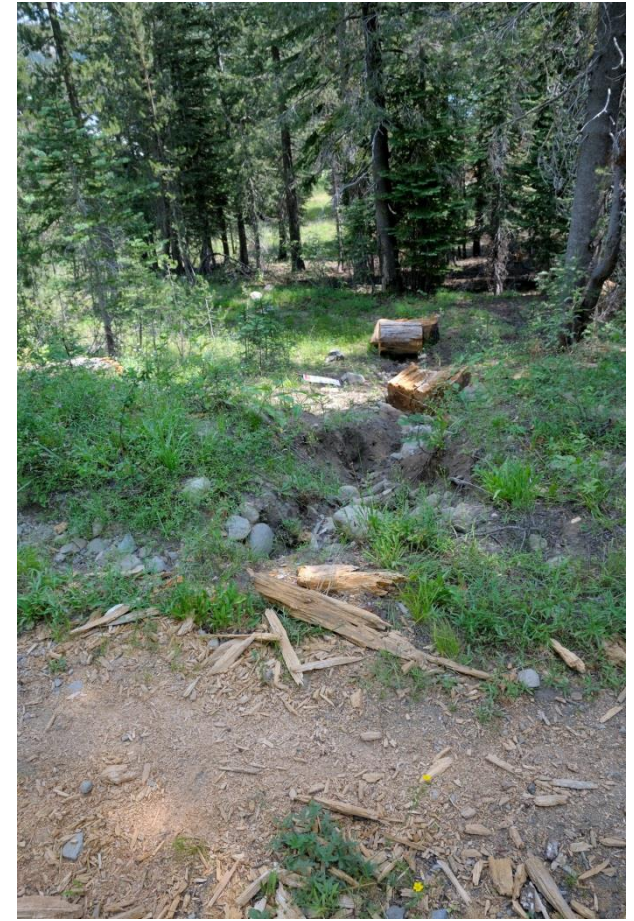
View: Downslope The tread is erosion resistant but the downslope erosion is significant. Drainage modifications will be required.

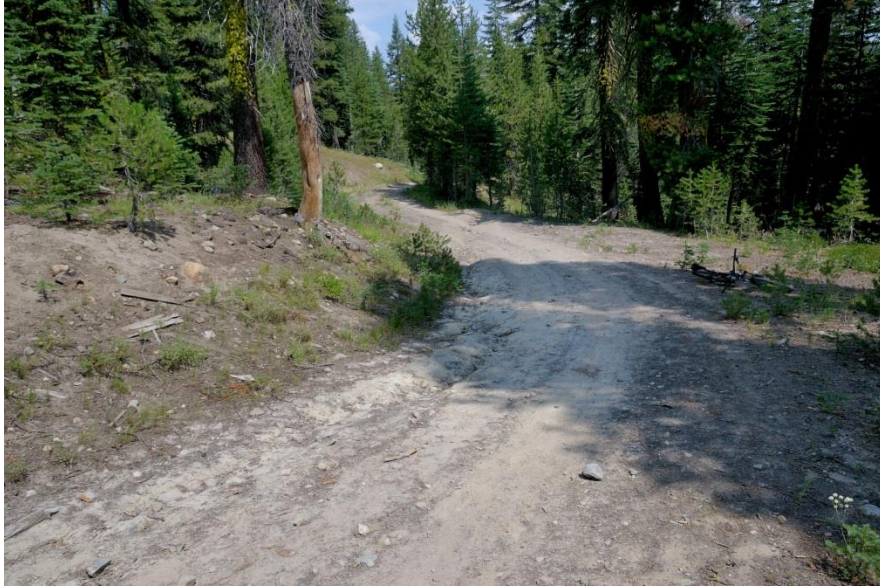
Erosion Point 18

View: North along trail. Reindeer trail at this point rises at a shallow slope and has a sweeping turn. The soil is loose when it dries out in July and does show erosion affects.

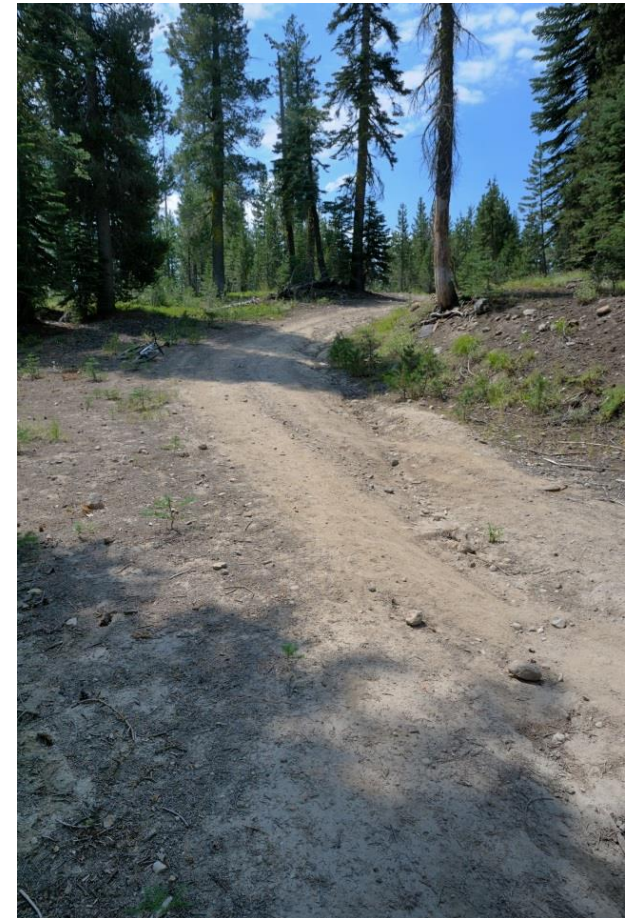
View: Upslope. The trail does partially follow the drainage line and drainage remediation is probably necessary. It is possible for mountain bikes to get speed up here so some grade modifications could be made to slow traffic.

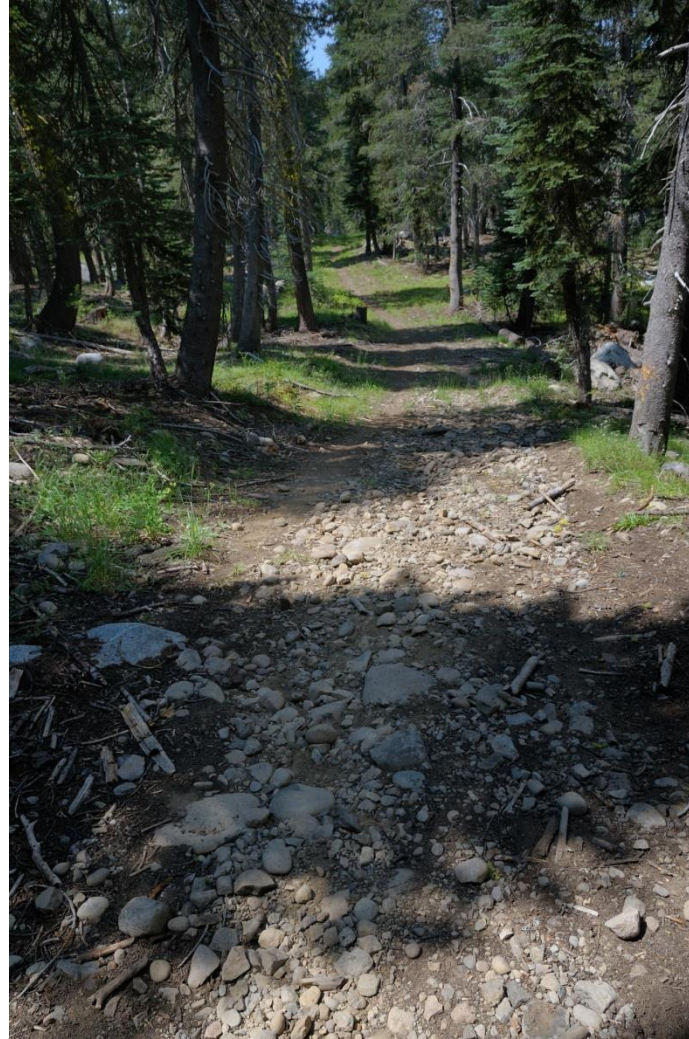
Erosion Point 19

View: South along trail. This is Reindeer trail on the east side of Serene Lakes. This particular section is right in the drainage line and the tread has been washed away leaving the underlying rocks. Drainage modifications would be necessary to remediate this section.

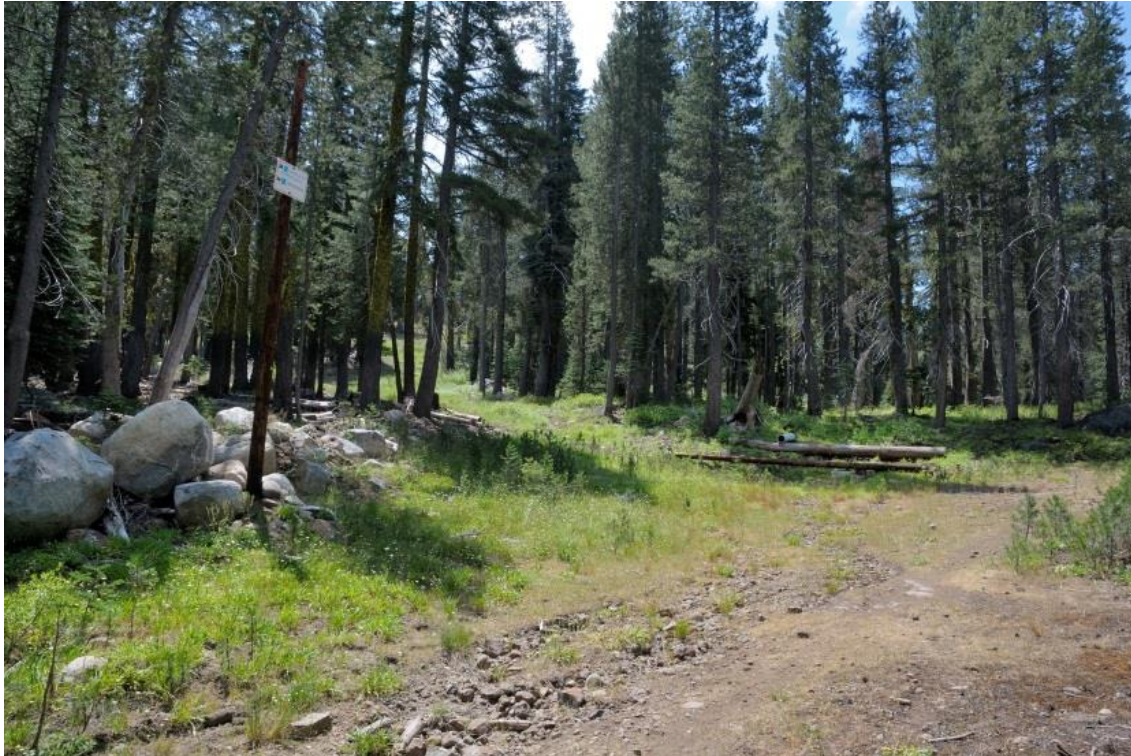
Erosion Point 20

View: South along Reindeer to intersection. This is the intersection of the Reindeer and Jack's Jump trails on the east side. Jack's Jump trail follows the drainage line down all the way from Razor Back ridge. There is some erosion where it intersects with Reindeer which effectively continues the drainage. Drainage remediation of both trails has been attempted in the past and more work will be necessary.

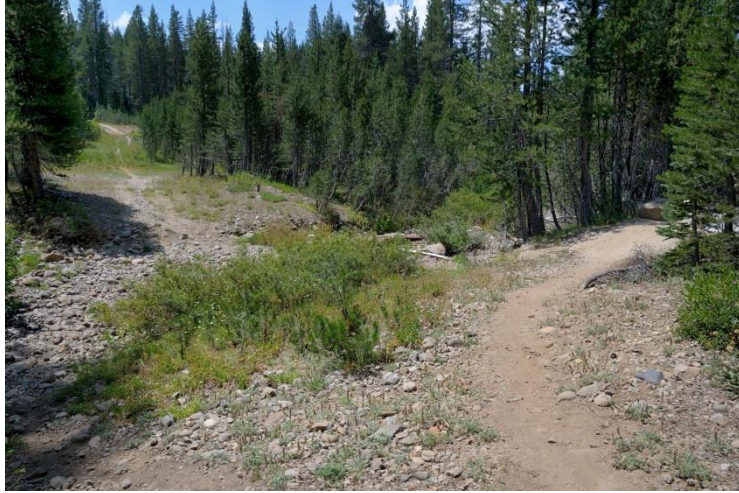
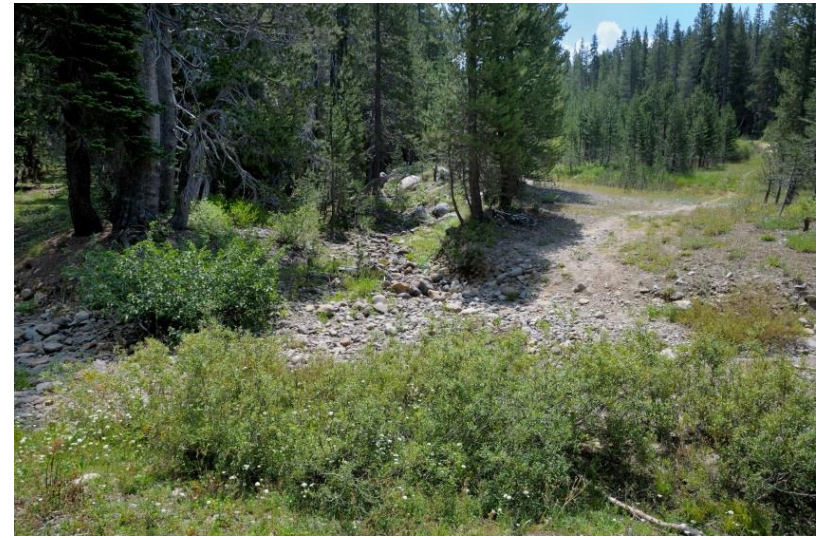
Erosion Point 21

This erosion point is at the intersection of the Reindeer trail and a primary inflow drainage creek into Lake Dulzura. The creek is washed down to the underlying rock where the trail crosses. Drainage on the trail could be remediated to form a better trail interface with the creek. The trail is flat and the tread is loose but does show some resistance to erosion.

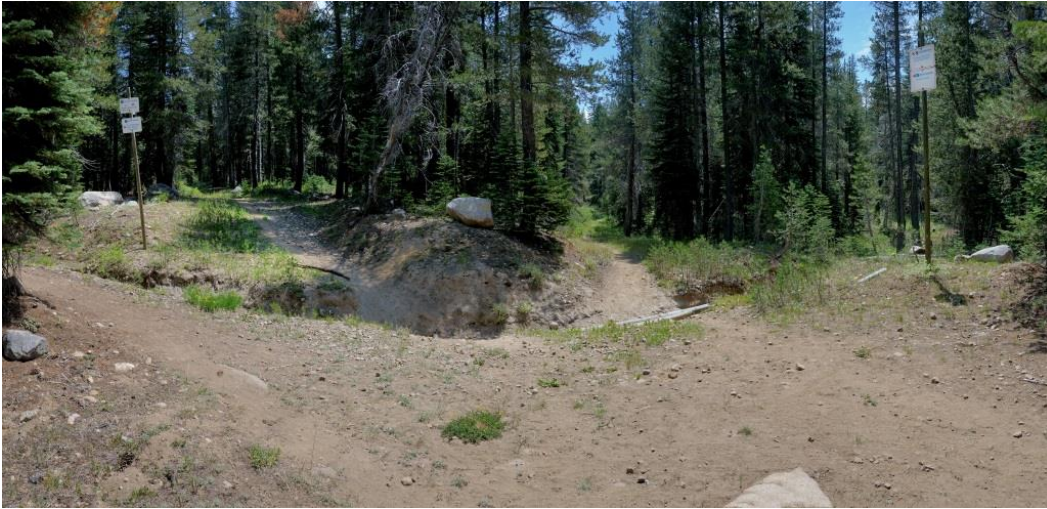
Erosion Point 22

View: Looking east at intersection. This is a major trail intersection between the Reindeer, Switchback, Claim Jumper and Overload trails. The same seasonal drainage creek that runs through Point 21 runs here. The treads for each trail are in good shape, but do show drainage erosion where they dip into the creek.

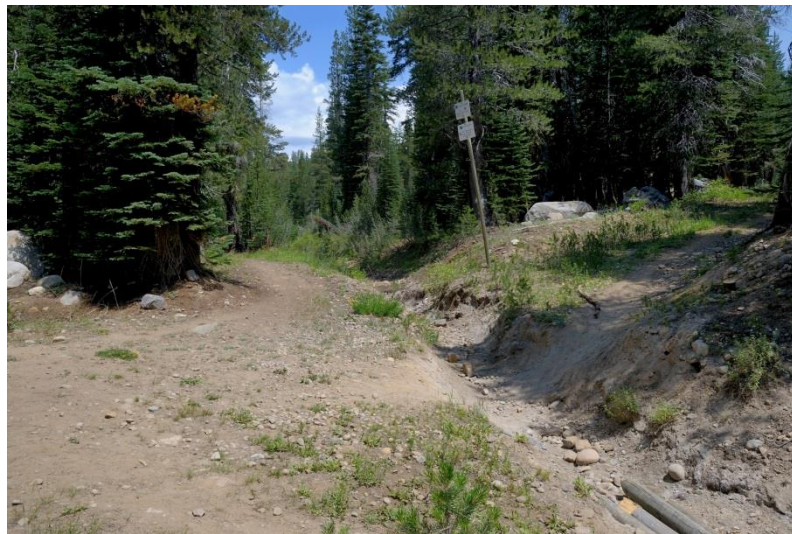
View: Looking north at intersection. The creek cuts deeply through the intersection of the trails. A bridge would help both hikers and bikers.
